Restoring a monument

The ASI is restoring the Ta Prohm Buddhist temple complex in Cambodia, which attracts hundreds of tourists every day.

BY T.S. SUBRAMANIAN RECENTLY IN SIEM REAP

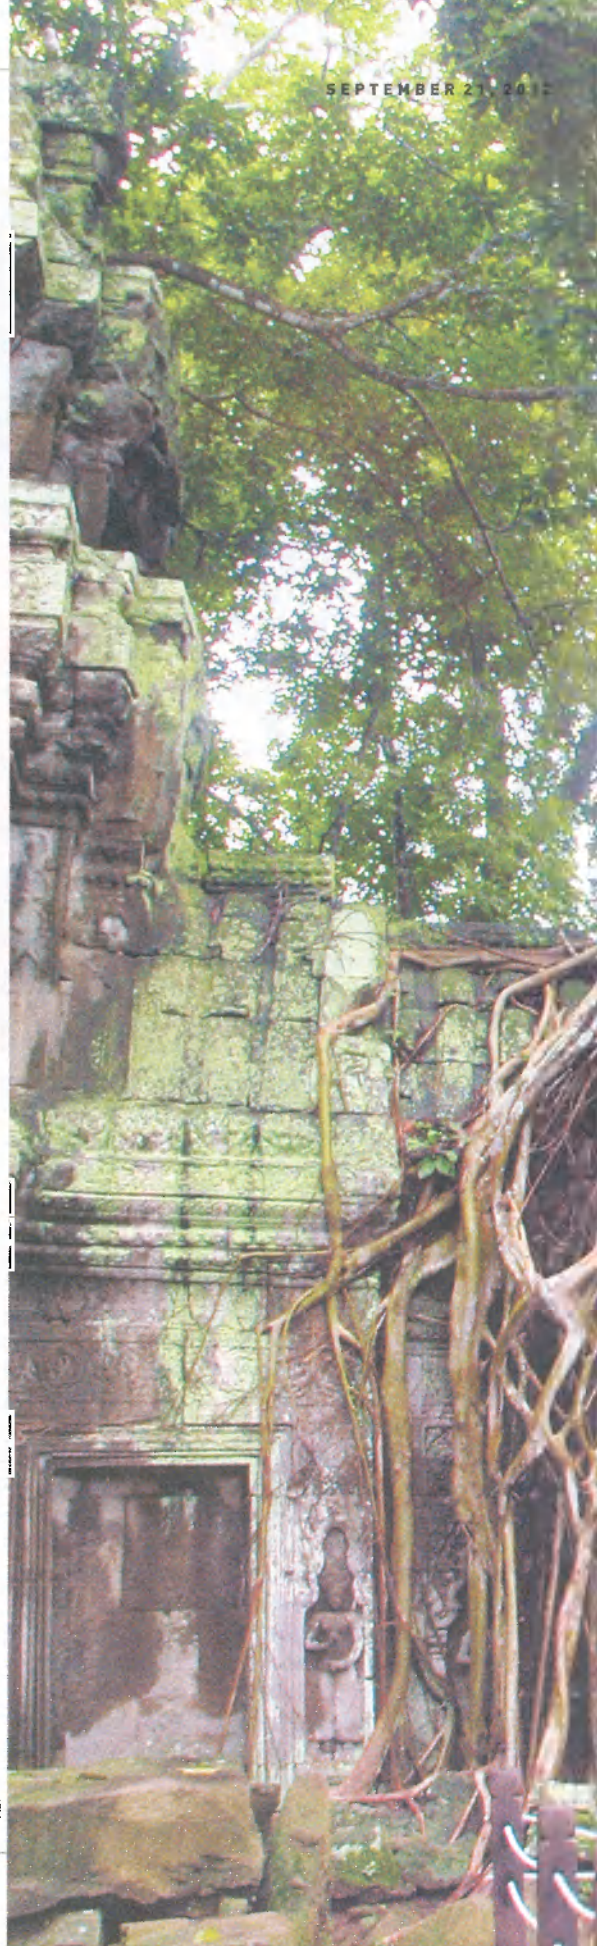
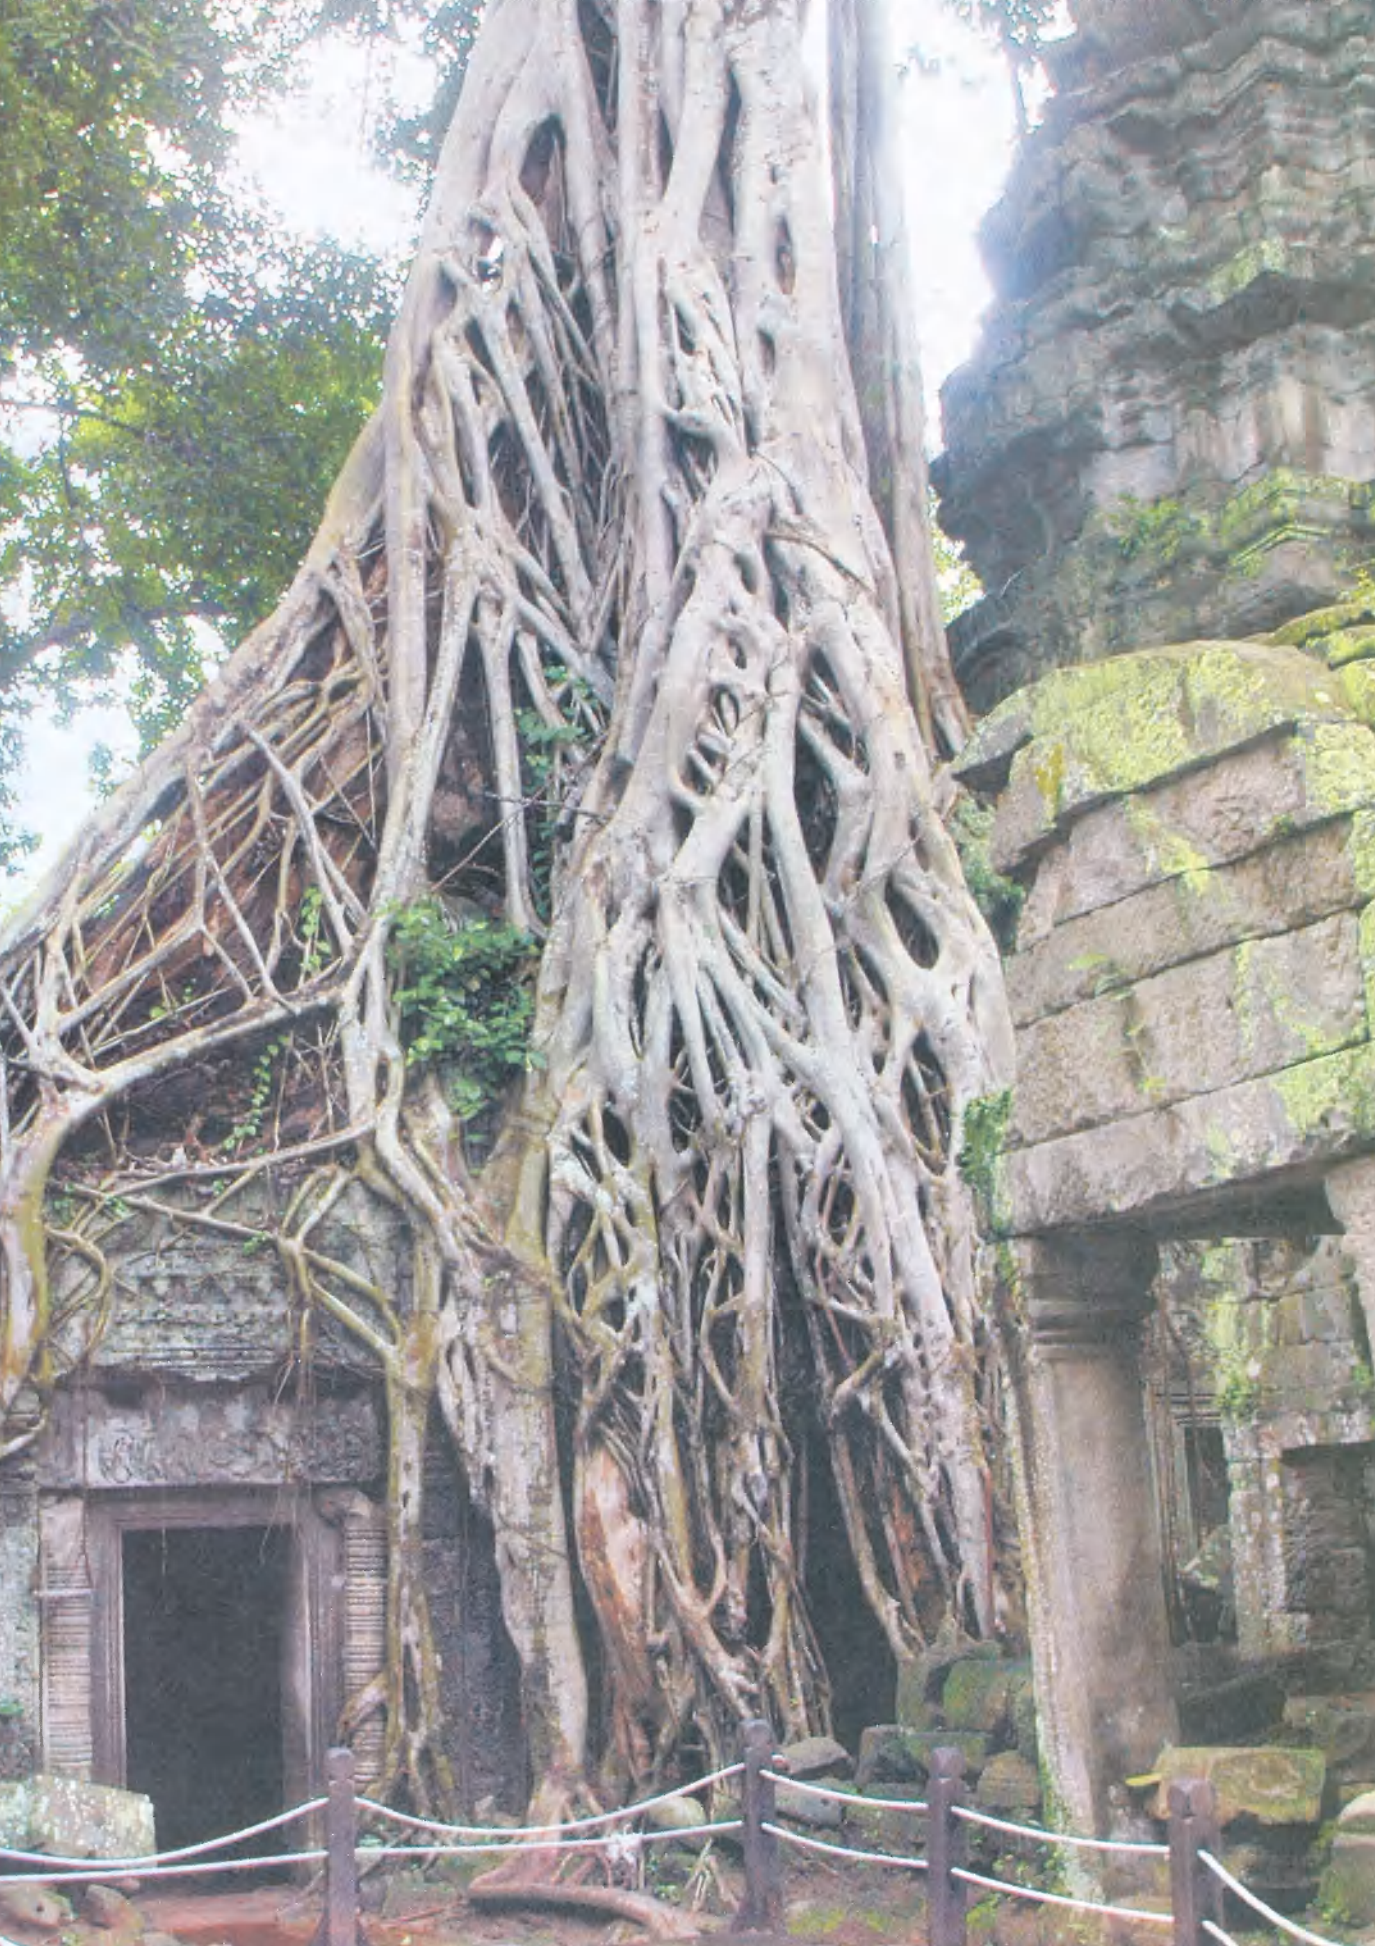
CREEPERS ENTWINE THE silk-cotton tree to form a trellis over a shrine at Ta Prohm.

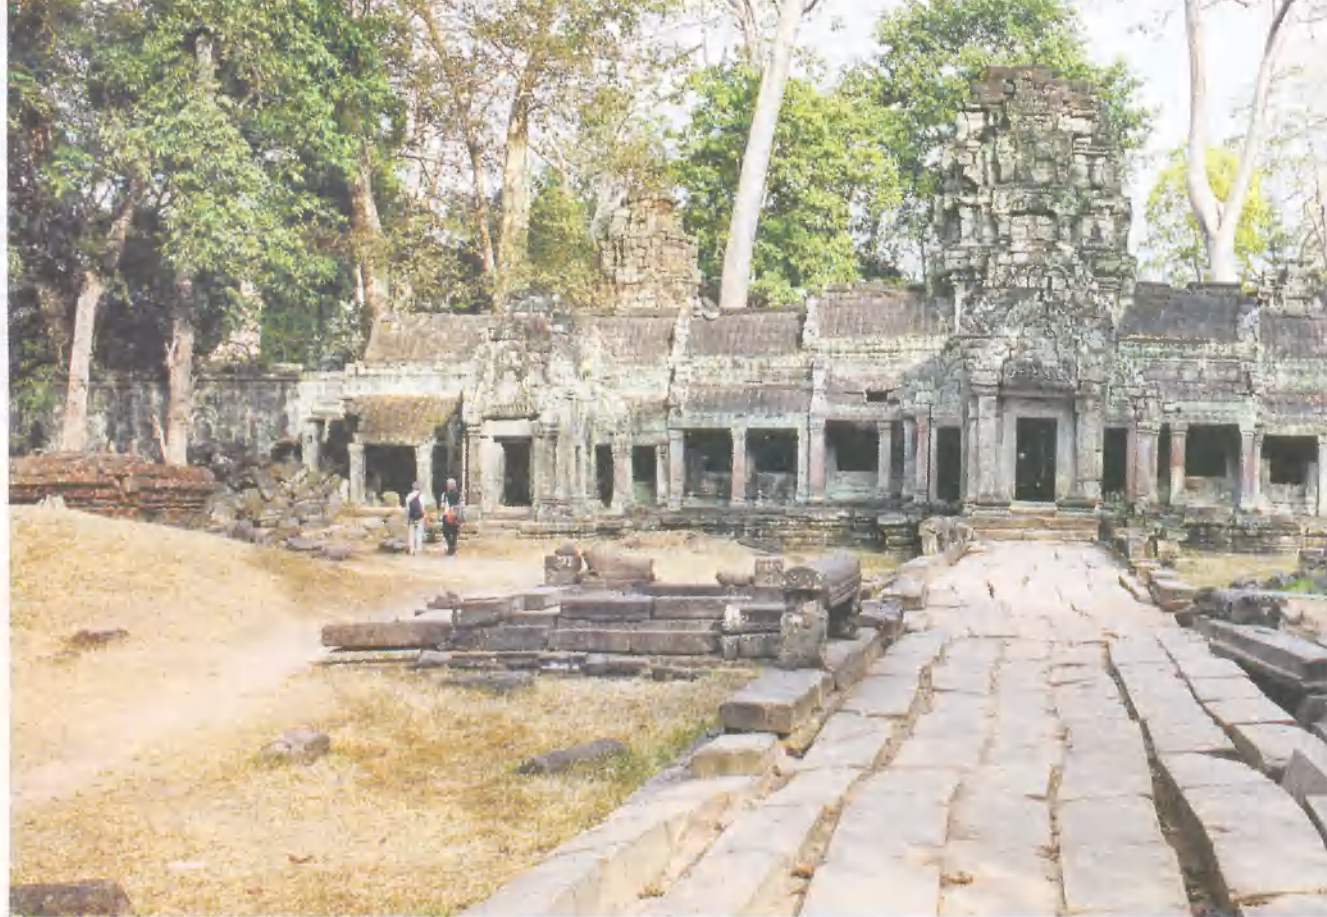
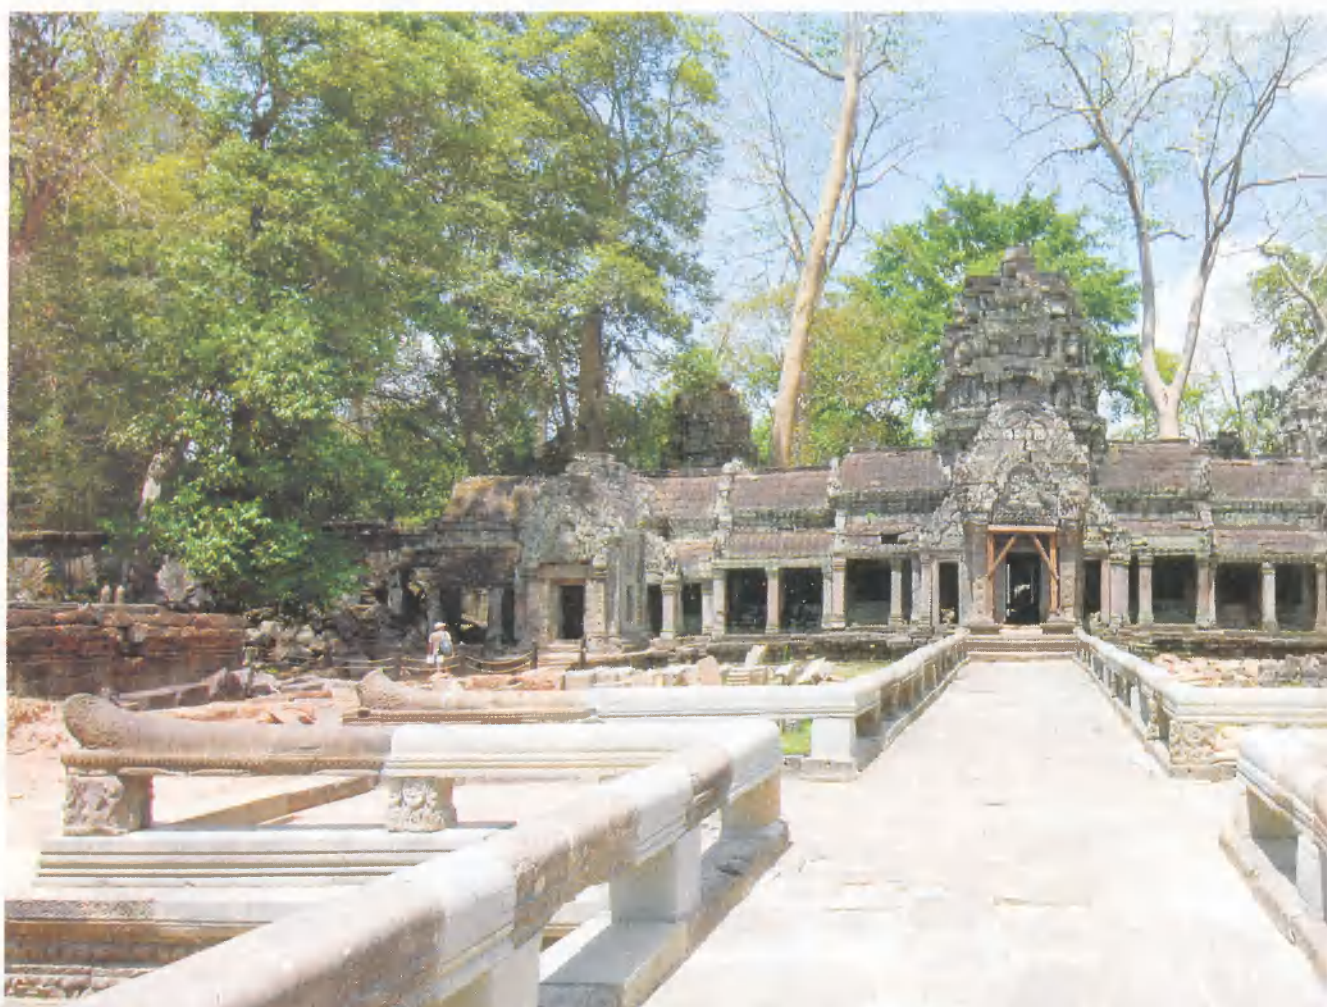
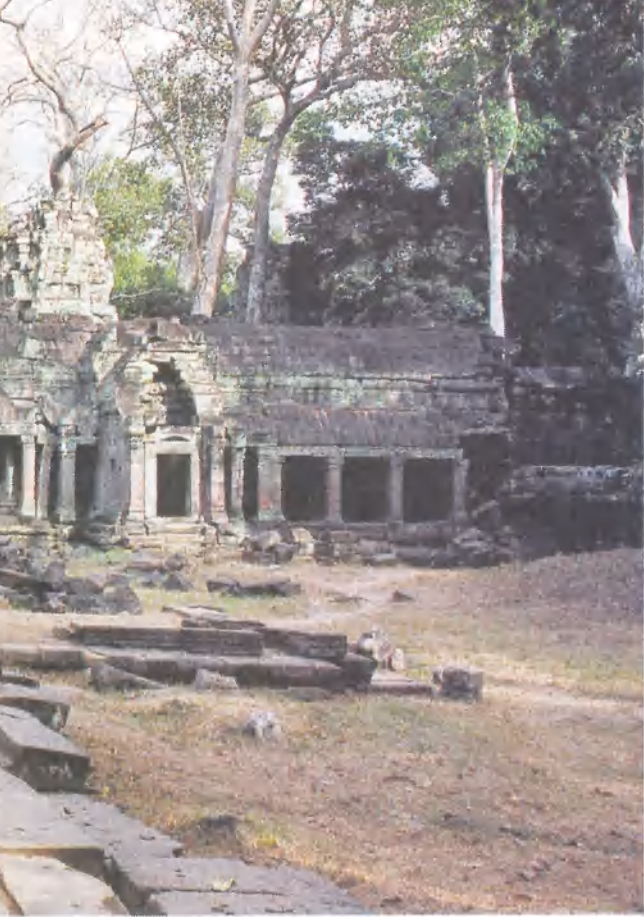
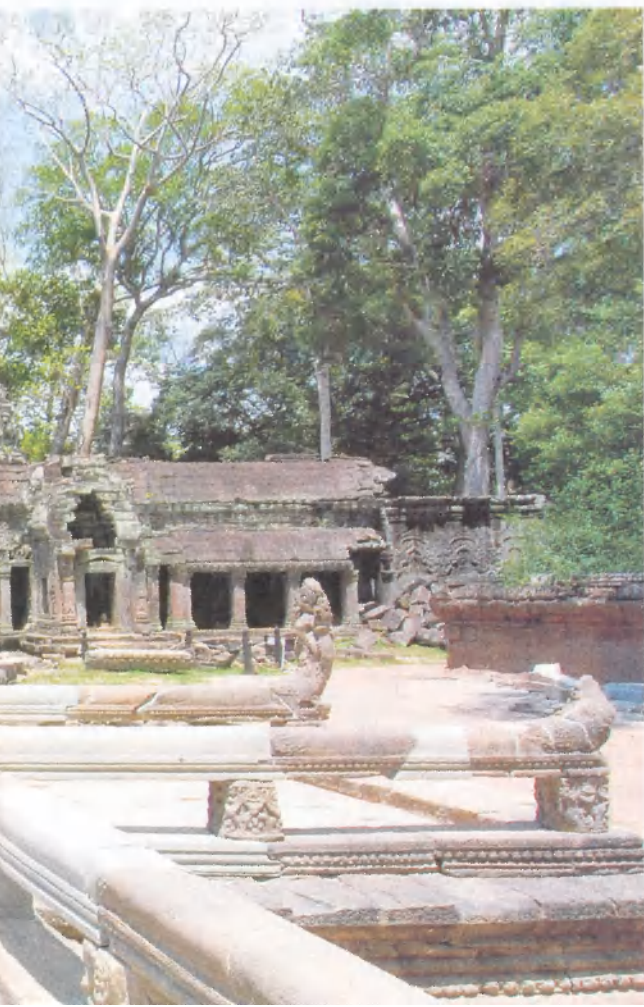
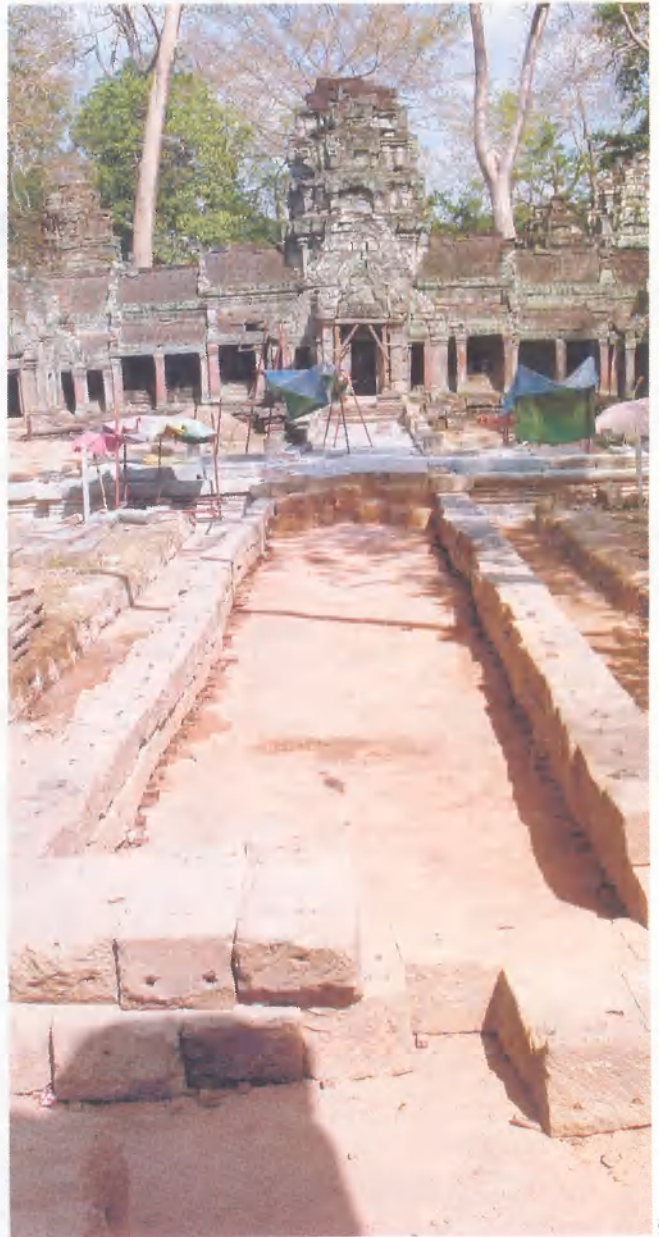
**(CLOCKWISE
FROM TOP, left)**
The causeway in
the Ta Prohm
complex, before,
during and after
its restoration.

The restoration of the causeway between the third and fourth enclosures was comparatively easy. The causeway is a broad footpath with a naga balustrade on either side (stone railing ending with a seven-headed serpent). The conservation work included treatment of the subsoil, resetting of the laterite base and core, and so on. The sandstone plinth and floor were re-assembled to their original alignment. "The naga balustrade has been restored by retaining the old stones wherever possible. Post-conservation drawings of the restored causeway have been prepared for comparative study," Biswas said.

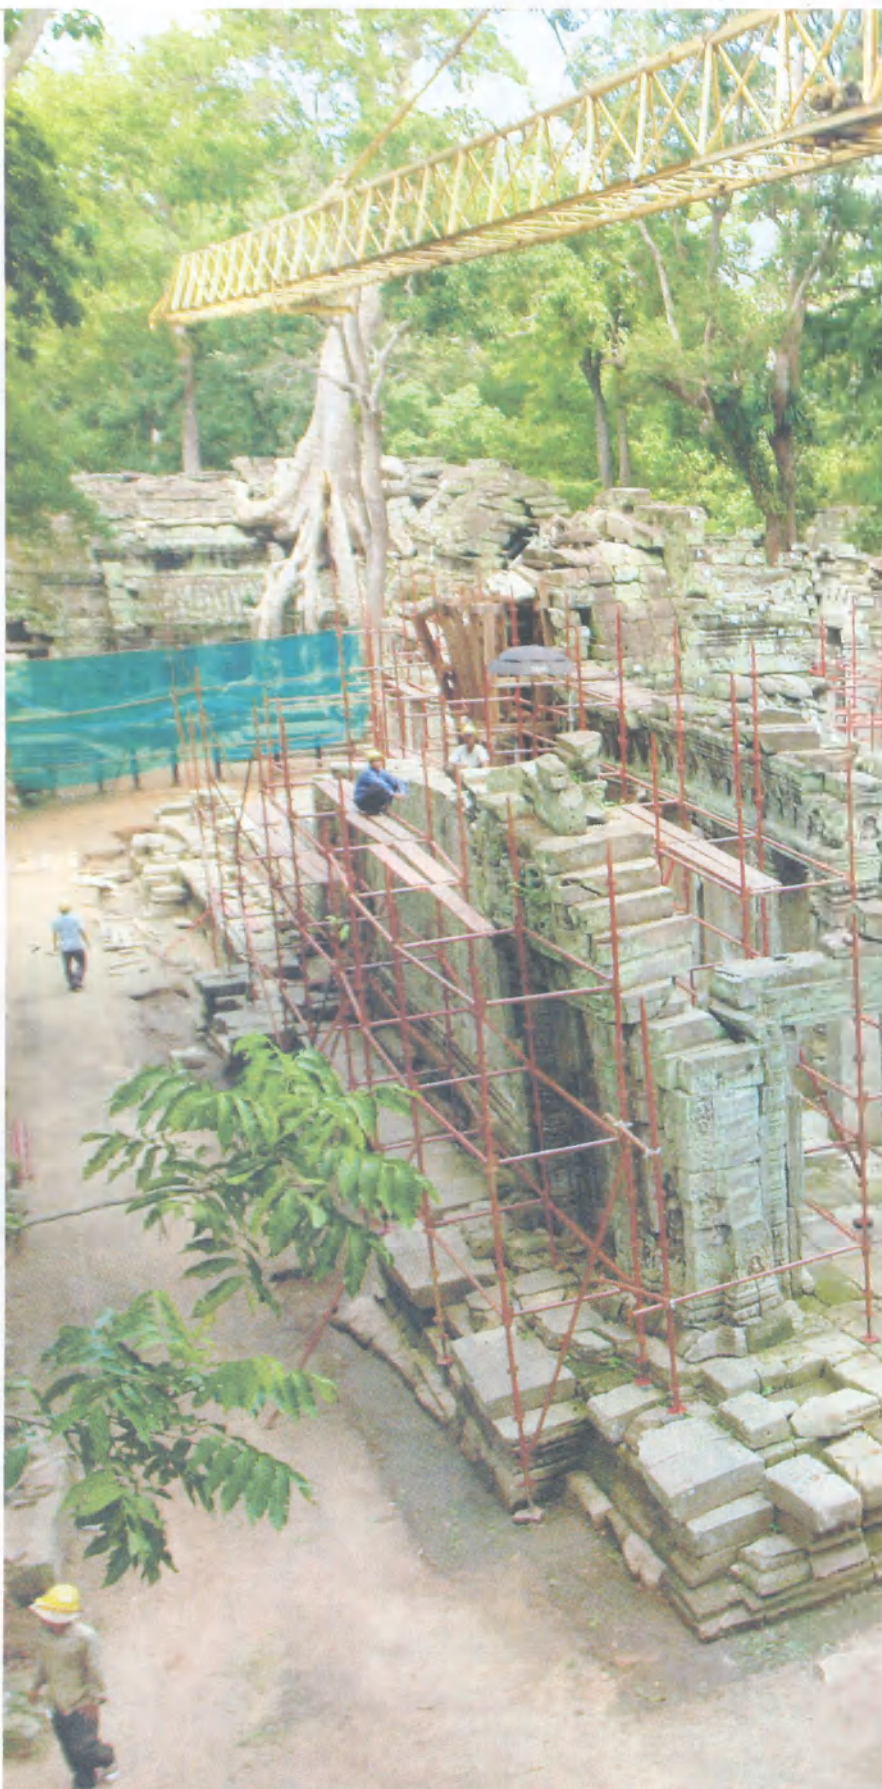
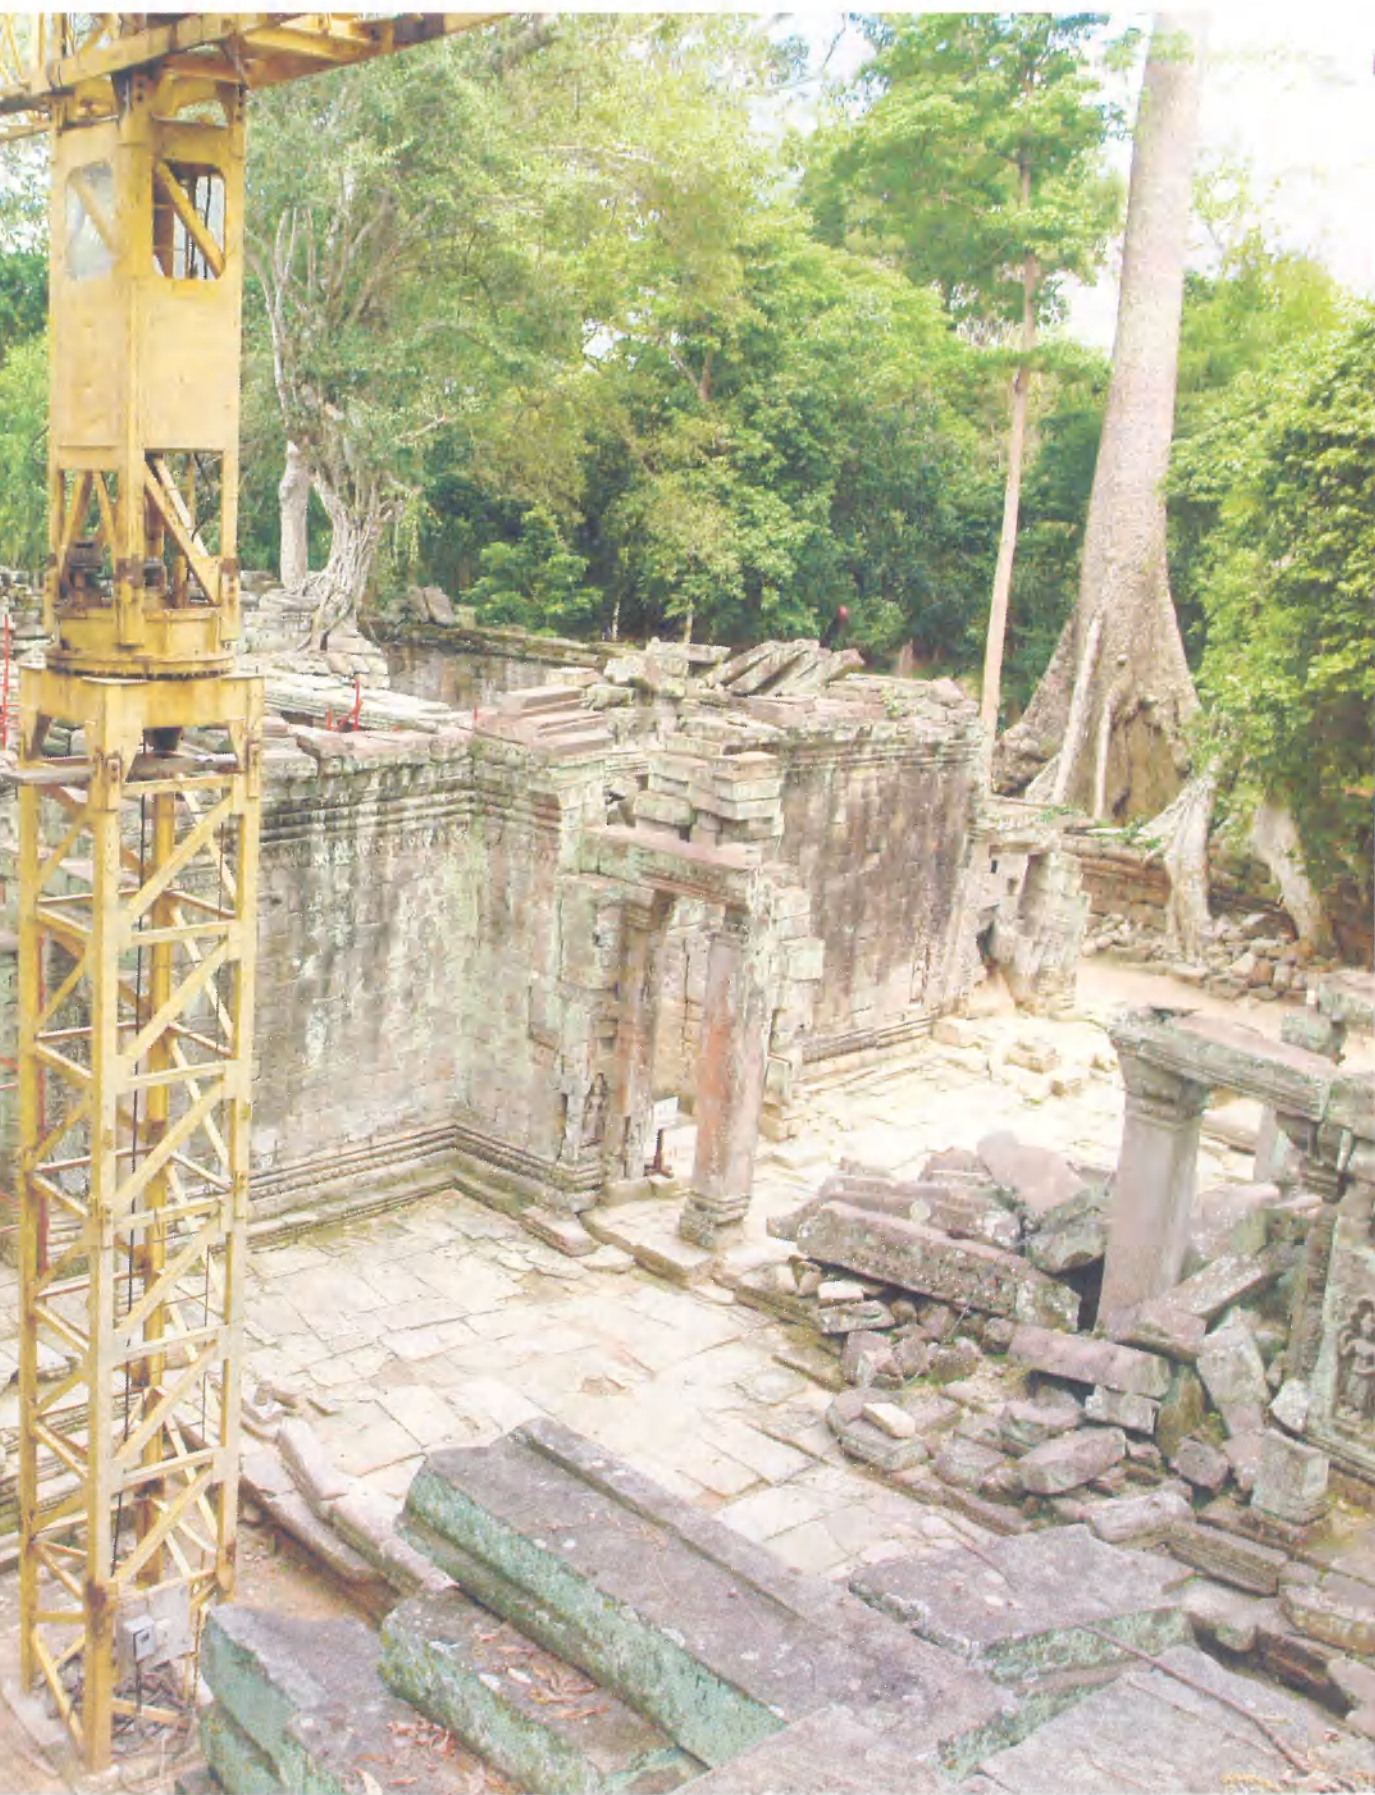
RESTORATION WORK GOING on at the Hall of Dancers.

Right now, restoration is under way in the hall. A tower crane is being used to lift and put aside the fallen architectural members after they are numbered and measured in situ. The laterite apron along the plinth has already been exposed and strengthened. The joining of broken pillars or archi-

tectural members using threaded steel pins, epoxy and polymer is in progress. The transformation that the complex has been undergoing is unbelievable. Sood said: "Documents were prepared to find out where the stones belonged because entire structures had collapsed."

The ASI documented every stone member layer by layer and grid by grid; measured every sandstone block for its length, height and width; and recorded their quality and orientation. The entire hall was photographed bit by bit. Then the dismantling of the floor was done, the soil was treated appropriately and sandstone blocks of the floor and the plinth were reset. The original broken stones of the floors, columns and roof were repaired and joined with appropriate material and threaded with steel pins. It was ensured that all architectural members achieved the desired structural strength before they were reassembled.

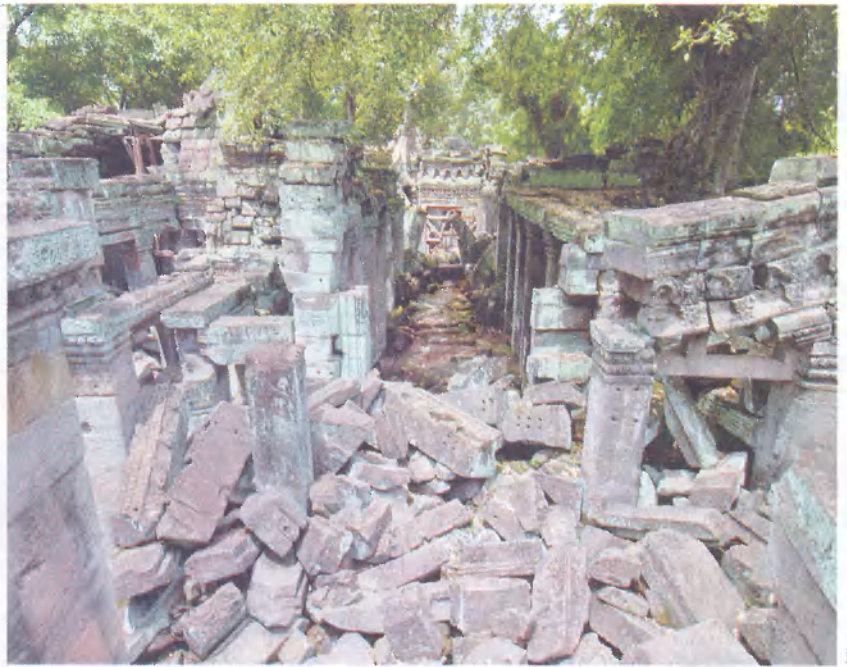
"The Hall of Dancers was in total ruins. We had no access to it," Sood said, recalling his first foray into it. "The ceiling had completely collapsed and it was lying in pieces on the floor. Most of the pillars were broken in two or three pieces. The porches had caved in," he added. There was chaos, with architectural members, lintel beams and broken pillars lying all around. The entire structure was clogged with water and there was a few feet of silt. What was benumbing was that three monstrously tall silk-cotton trees [*Ceiba pentandra*] had grown inside the hall, dislodging its sandstone blocks, driving cracks in the wall and heaving up the floor. "The vegetation had penetrated the foundation and it was not safe for tourists to go inside," he said, as he displayed pictures of the ruins taken in 2004.

THE HALL OF DANCERS before restoration work began. The ASI team found that the ceiling had completely collapsed, most of the pillars were broken in two or three pieces and the porches had caved in.

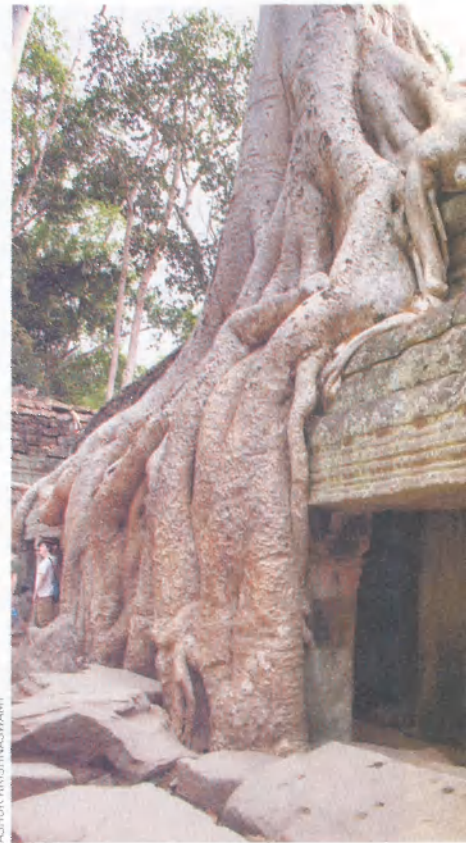
plex. There were stunning sights everywhere. A 30-metre-tall silk-cotton tree soared into the sky with its massive roots gripping a *vimana*. The roots had formed a trellis over the carvings above the shrine’s doorway. The *vimana* was in a precarious position, with the tree having dislodged its

A SHRINE IN the firm "grip" of a silk-cotton tree.

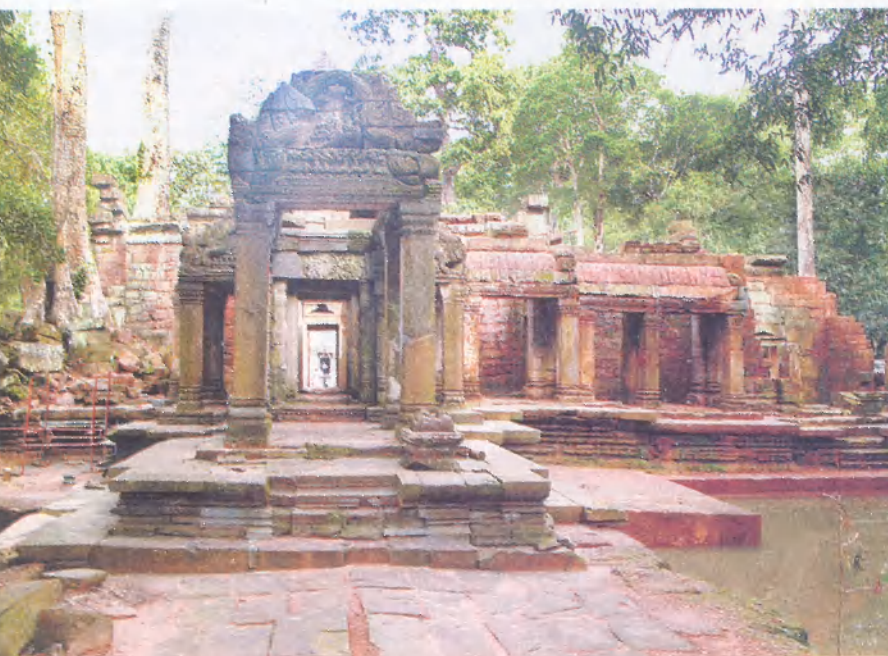
THE ENTRANCE GOPURA, before (facing page) and after restoration.

Restoration of the entrance gate *gopuras* is under way. In these *gopuras*, the stones have been arranged in such a way that they resemble the visage of Avalokitesvara. But neglect led to these stones being dislodged from their positions. They have been readjusted and repositioned with the help of a chain pulley.

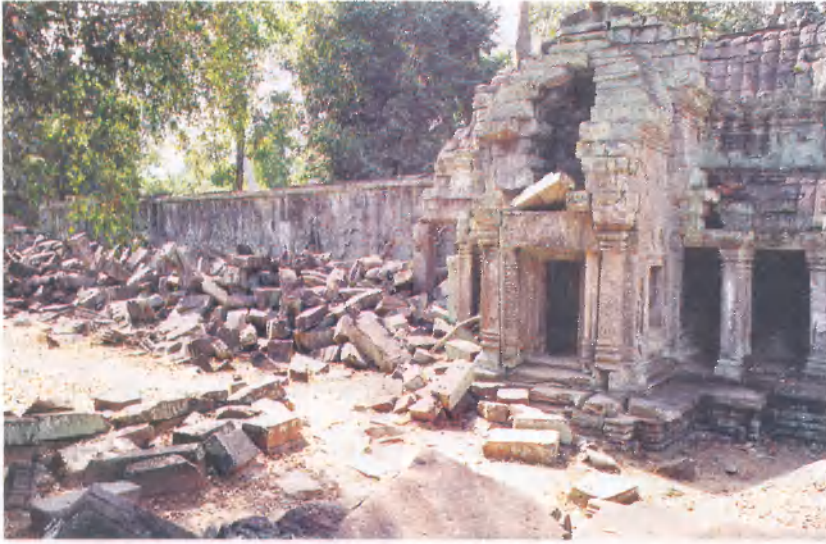
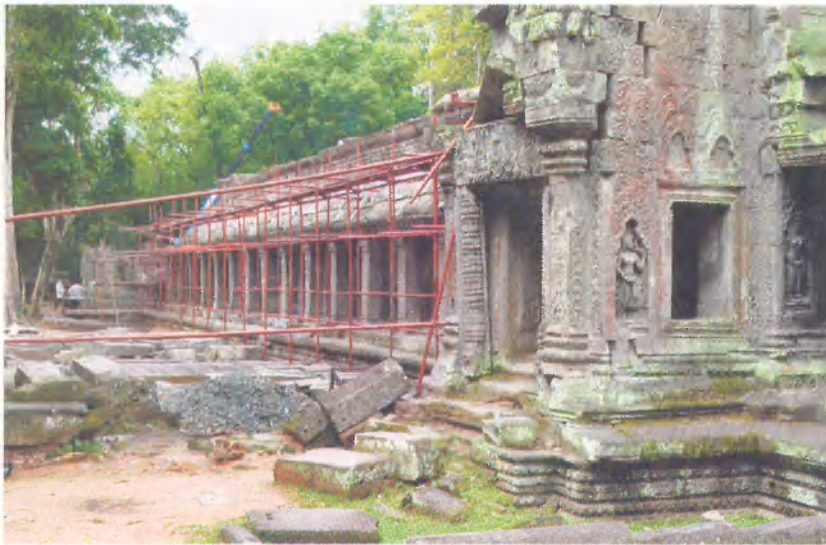
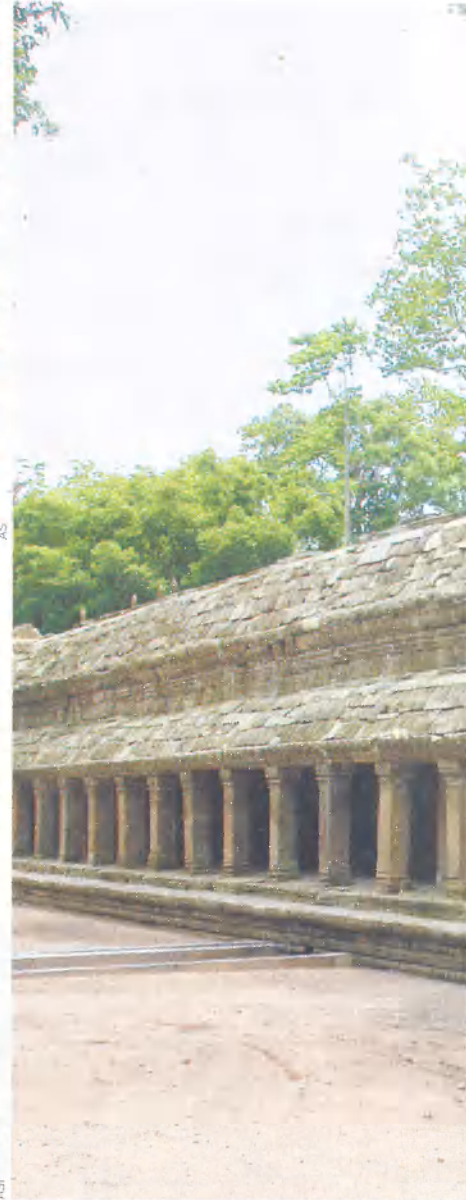
THE RUINED STATE of the gallery located between the third and fourth enclosures before its restoration; (below) scaffolds erected for its restoration; and (right) after the restoration was completed in 2010.

The first structure that the ASI team restored was the third enclosure gallery. "It had collapsed completely," said Sood. The gallery was a long verandah-like structure, 41.15 m long and 4.85 m broad. It had two rows of sandstone columns [pillars] in front and a continuous wall in the rear, and a shrine in the centre. The gallery had corbelled roof, supported by the wall and the sandstone columns. The wall had niches with big carvings of apsaras, mythical animals, and so on. [The niches are barren now as the carvings were hacked off during the reign of Jayavarman VIII.]

roofless verandah with the corbelled roof, broken pillars and a ruined shrine lying on the ground. The beautiful gallery had virtually become debris. The gallery's restoration work was completed in 2010. "A trial assembly was conducted before the actual reconstruction of the gallery on the site," Sood said.

The principle of anastylosis was adopted in the restoration work: original stones found at the location were used to the maximum extent and new stones were inserted only when absolutely necessary. Janhwi Sharma, Director (Conservation), ASI, told the ICC that only 5 per cent of new stones were added in the gallery and that it was done only where it was structurally necessary.

Sood said, "During the restoration, we used the same technology [used by Khmers]. We did not use any mortar or other binding material. We were very clear that we would not use broken stones without joining them. If a

stone was broken into several parts and all the broken parts were available, we joined them together. We joined the broken pieces by drilling and inserting steel pins inside."

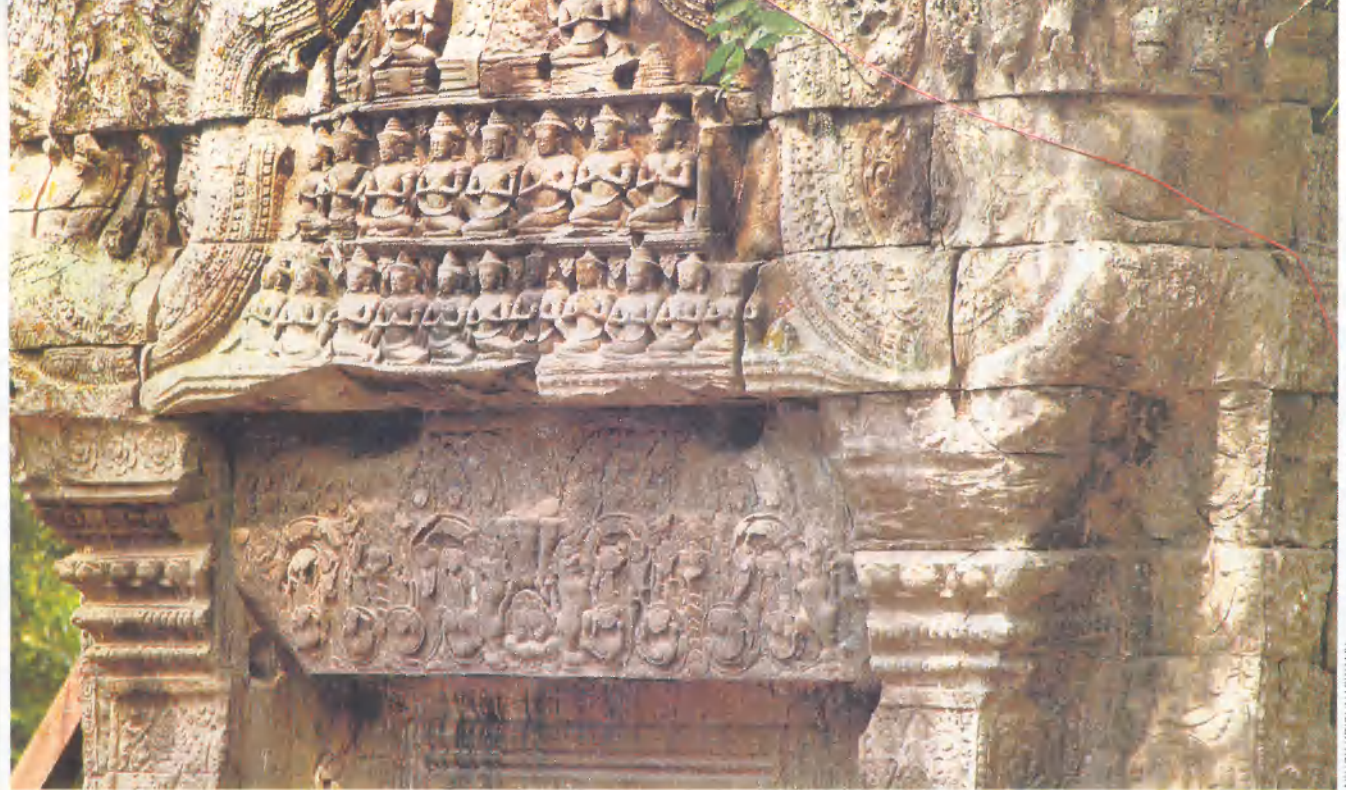
DETAILS OF A torana in the Ta Prohm complex.
